# Struck by lightning

and stuck in harbour in Sweden

Nick Charman

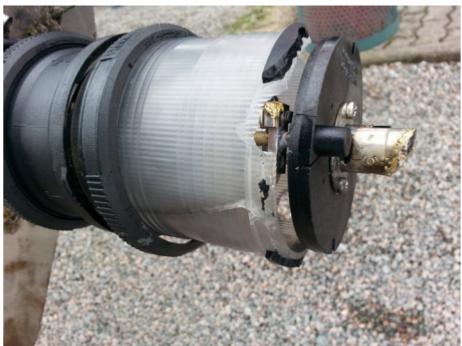
Masthead light . . .

The masthead light took the initial strike, of course, and has been partially melted. All the other navigation light fittings on that mast were charred. The burgee pole is now somewhat charred, and metal fittings on it partially melted, but the RCC burgee itself is apparently of tougher stuff, and is undamaged. (May I pause here and expose an image that has come to mind? – that of me explaining to the Commodore at the Beaulieu Meet, why the RCC burgee is now apparently flying inferior to what seems to be an upside-down loo brush . . . Perhaps I shall cross that bridge when I come to it.)

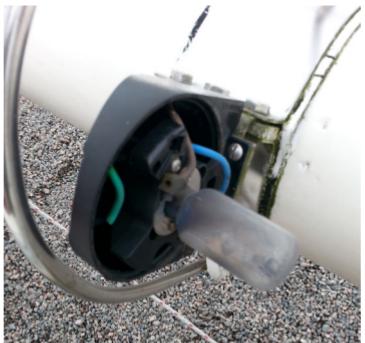
. . . and steaming light

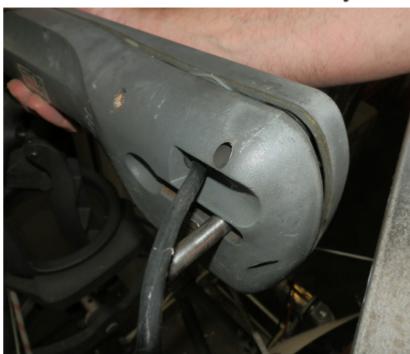
The most obvious externally visible damage has been the charred wires in the mast and at the junction boxes. The anchor light LED on the switchboard exploded, leaving a small litter of broken glass below it. The reason why the self steering had ceased to work was that the Tillerpilot, attached to both the taffrail and the Aries, had blown apart. While in light airs we had been using it to drive the Aries, and in the process had formed an electrical path from the taffrail to

Tillerpilot split by an explosion inside

the Aries itself. The Aries top clamp had signs of electrical arcing.

My theory, although not provable, is that the energy in the initial upward leader found a route from the water, via the Aries water servo-blade, to the taffrail via the Tillerpilot, then along the guardrail and forward. The children in the saloon both reported looking up when we were hit and seeing ‘fireballs’ passing along the deck. It may well have been current along the wire guardrails, from aft to forward.
