RCC Pilotage Foundation Atlantic Islands

7th Edition 2021

Supplement No.2: Supplement May 2024

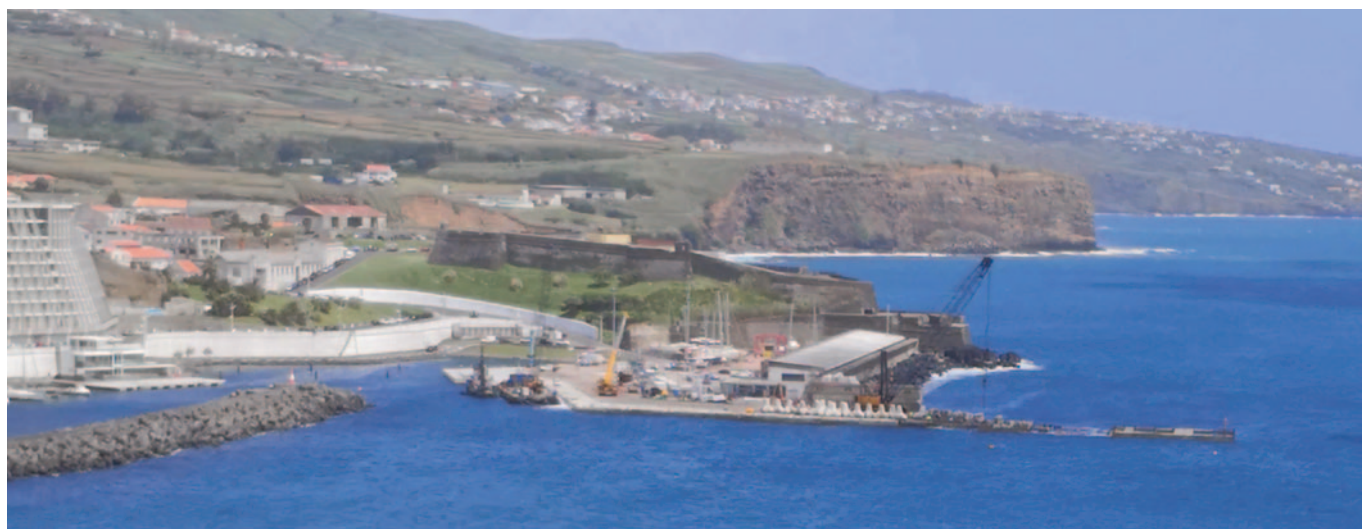
Ongoing work at the harbour entrance of
Marina de Angra do Heroísmo

Following the decision to build a RoRo berth in Porta das Pipas, there has been a considerable change to the harbour entrance at the Marina de Angra do Heroísmo and care should be taken when entering. The eastern harbour wall has been lengthened by about 100m and as work is still ongoing it would not be prudent to attempt a night entry, but rather go to anchor and wait until marina office hours (08:00 in the summer months). The photograph indicates the length of the new wall. There are a number of buoys marking the navigable passage into the marina.

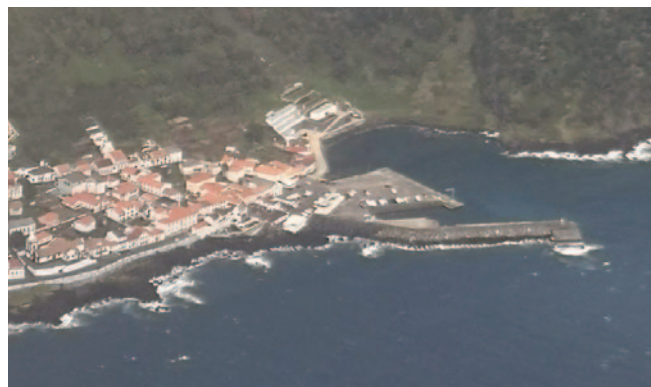
Page 106 Calheta

The aerial view of the harbour at Calheta, taken from a commercial airplane, shows the positioning of the RoRo berth, the inner wall and the Museu Francisco de Lacerda at the head of the bay.
